Exeter Flood Risk Management Project

Levee Inspection Report

Name of System: Exeter - Hicks Creek

Inspection Report Prepared by: Daniel Risley, USACE Baltimore Date(s) of Inspection: 06/05/2024 - 06/05/2024

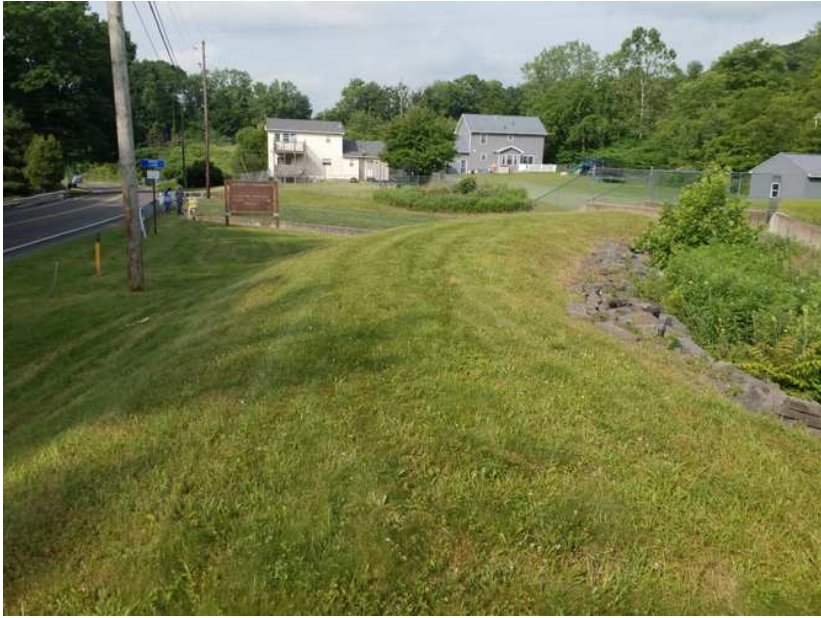
Inspect ID: 2024-0002

Typical conditions: Debris Basin Embankment, note vegetation at toe on wet side (M)

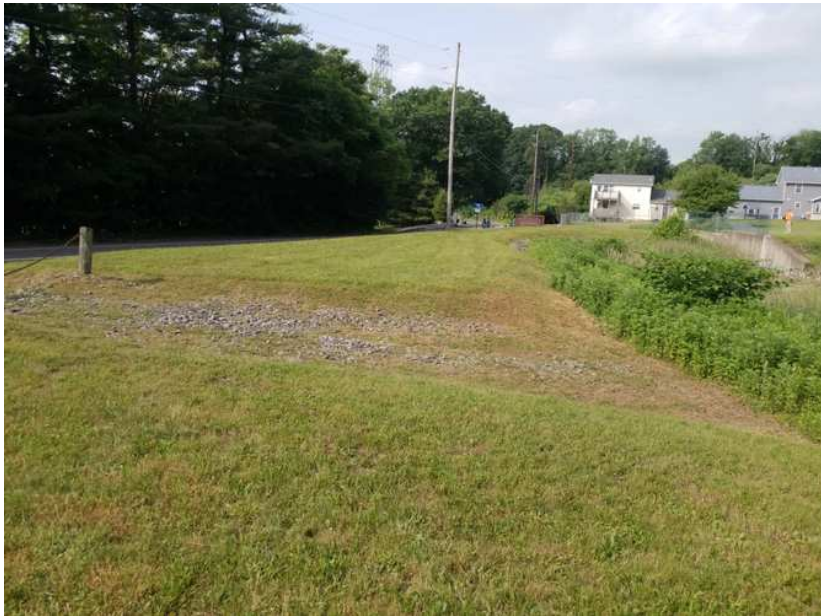
Inspect ID: 2024-0003

Typical conditions: Debris Basin Embankment, note vegetation at toe on wet side (M)

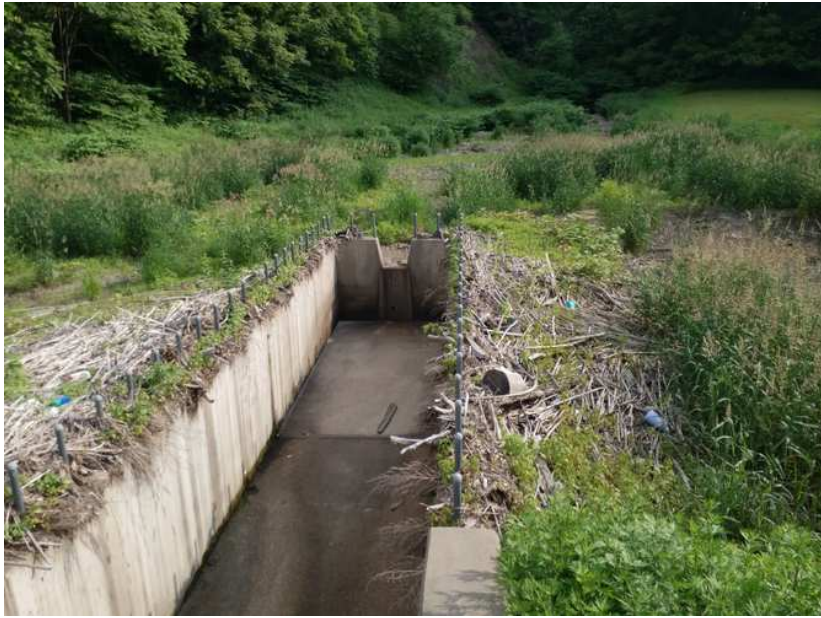
Inspect ID: 2024-0001

Outlet structure. Debris basin is full. Sponsor stated they are planning to clean out. Has been to wet (M) Concrete in good condition

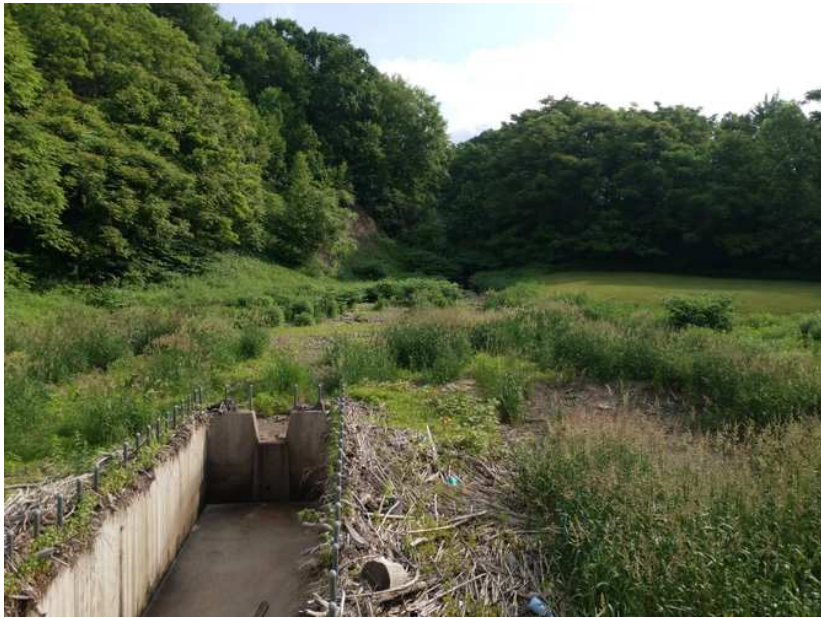
Inspect ID: 2024-0001

Outlet structure. Debris basin is full. Sponsor stated they are planning to clean out. Has been to wet (M)

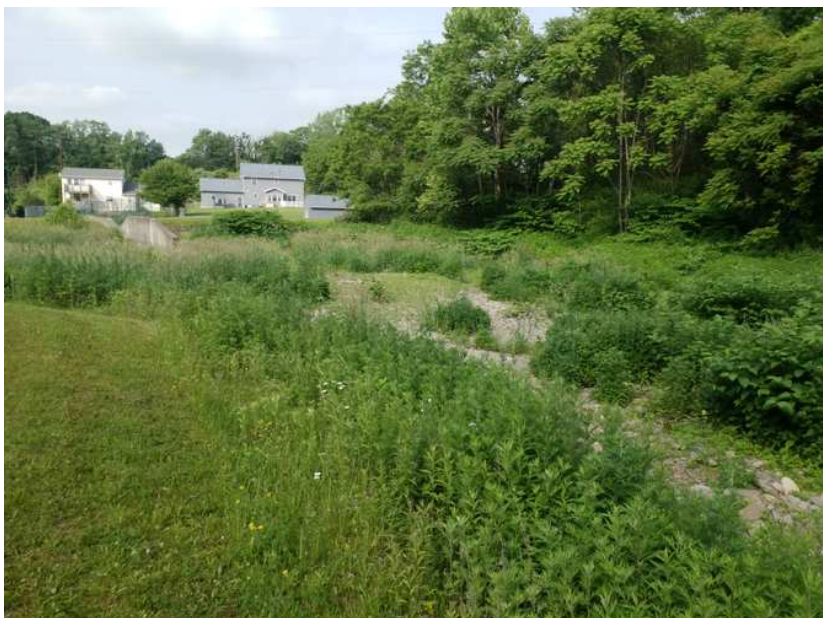
Inspect ID: 2024-0004

Outlet structure. Debris basin is full. Sponsor stated they are planning to clean out. Has been to wet (M)

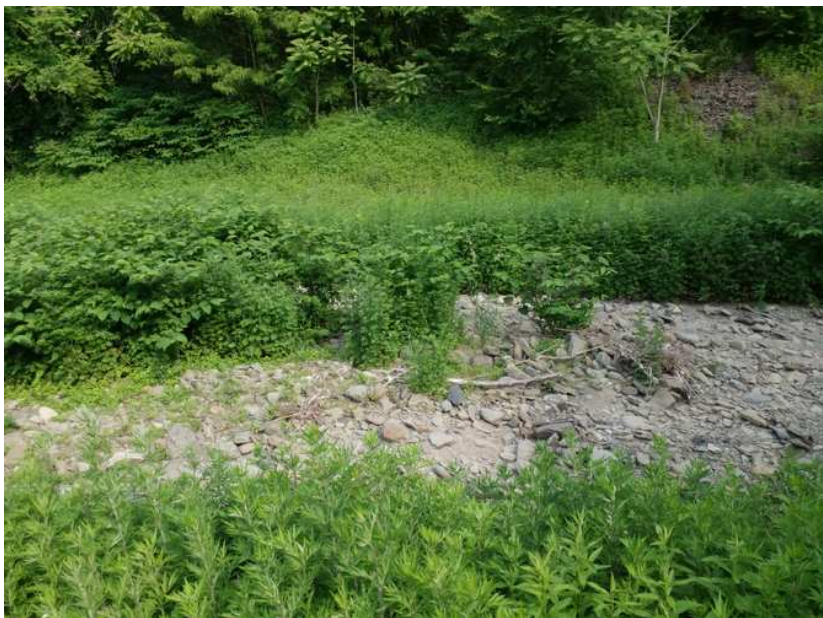
Inspect ID: 2024-0004

Outlet structure. Debris basin is full. Sponsor stated they are planning to clean out. Has been to wet (M)

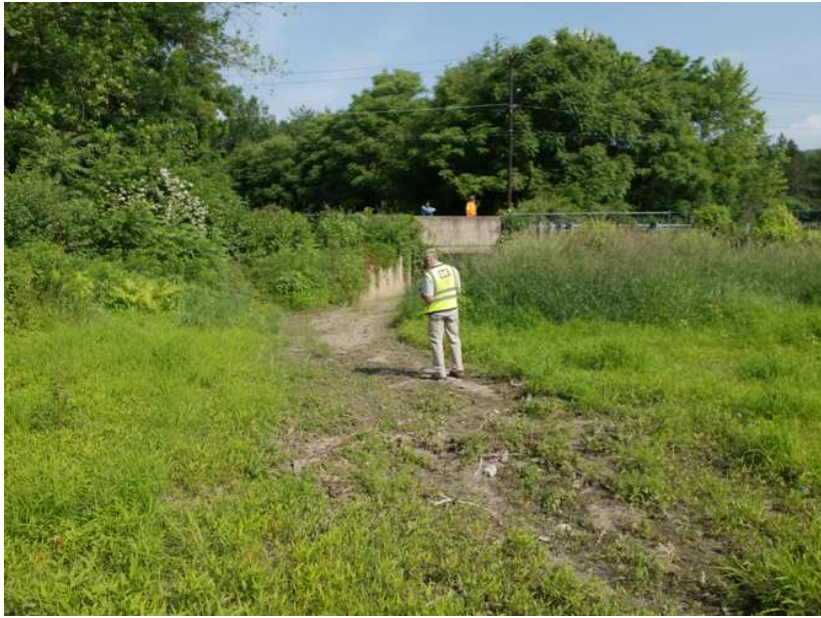
Inspect ID: 2024-0021

2. Shoaling (sediment deposition)	M	A	No shoaling or minor, non-vegetated shoaling is present.	
		M	More widespread vegetated and non-vegetated shoaling is present. Non-aquatic grasses are present on shoal. No trees or brush is present on shoal, and channel flow is not significantly reduced. Sediment and debris removal recommended.	2024-0019 Concrete channel is 90% full of sediment. Concrete portion is 18 inch high. Sponsor needs to clean out. (M)
		U	Shoaling is well established, stabilized by saplings, brush, or other vegetation. Shoals are diverting flow to channel walls. Channel flow capacity is reduced and maintenance is required.	2024-0020: Culvert is highly impacted by sediment. Estimate 25% blocked. Sponsor should clean out. 2024-0021: Typical conditions. A few feet of sediment is in the Strumer Street basin. Sediment should be removed (M)

Typical conditions. A few feet of sediment is in the Strumer Street basin. Sediment should be removed (M)

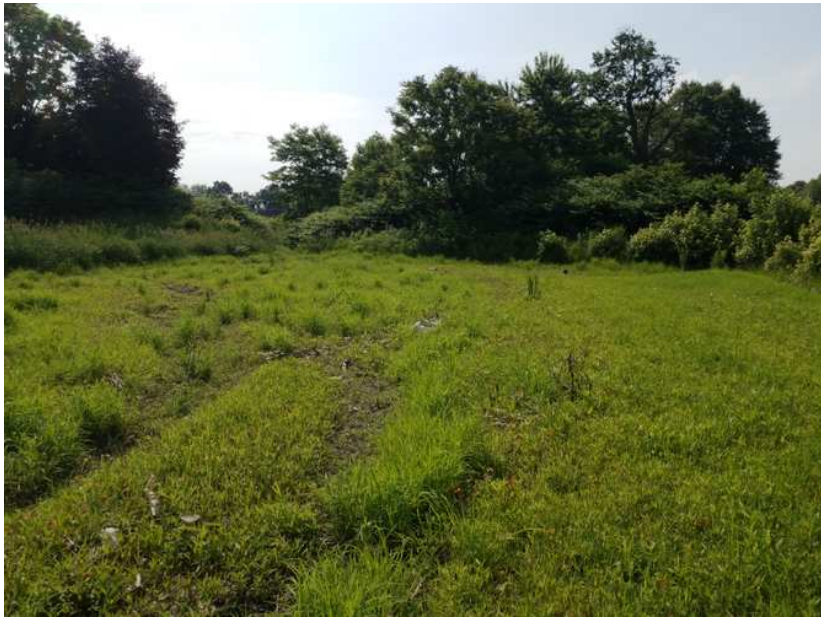
Inspect ID: 2024-0021

Typical conditions. A few feet of sediment is in the Strumer Street basin. Sediment should be removed (M)

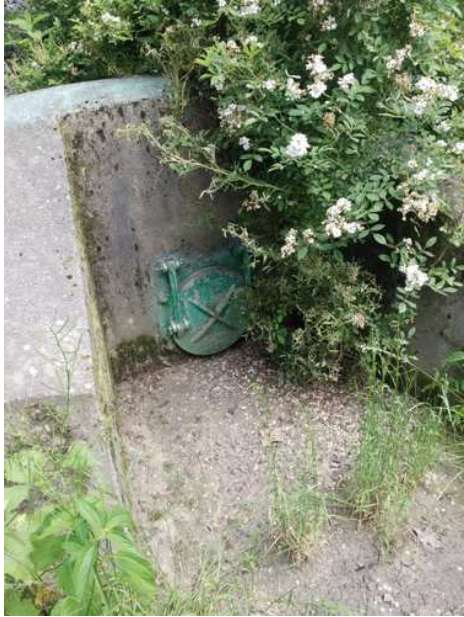
Inspect ID: 2024-0030

Typical conditions of SWM facility at low flow outfall. Vegetation needs to be cleared out, Donna's Way facility (M)

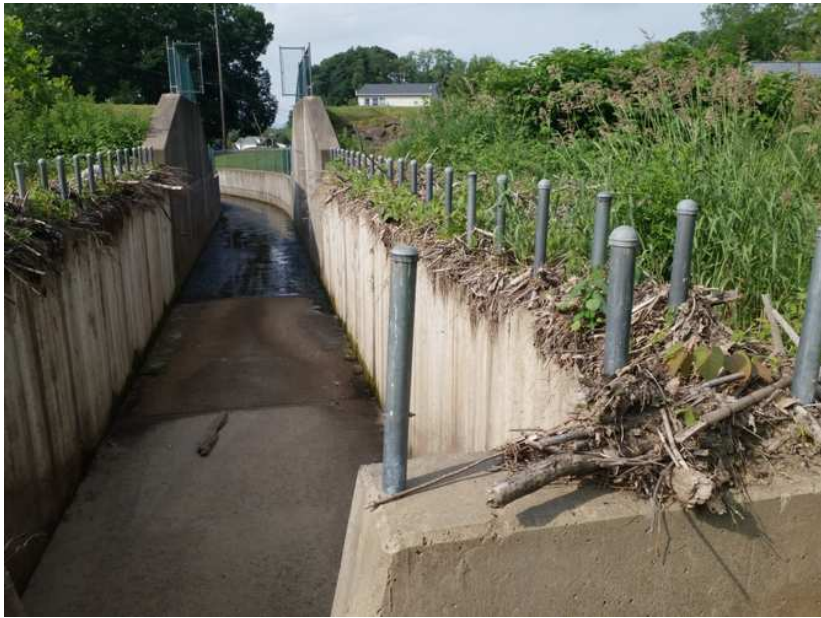
Typical conditions at debris basin, debris should be removed (M)

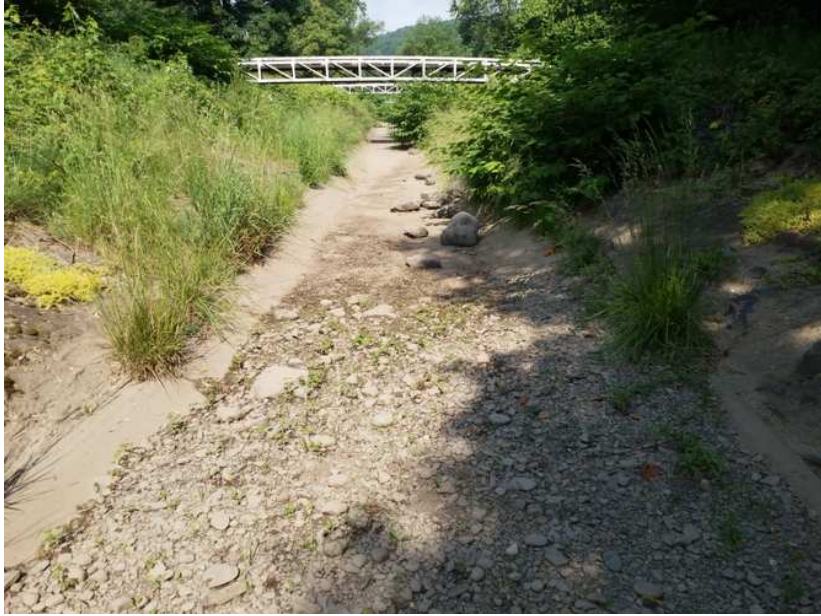
Typical conditions at debris basin, debris should be removed (M)

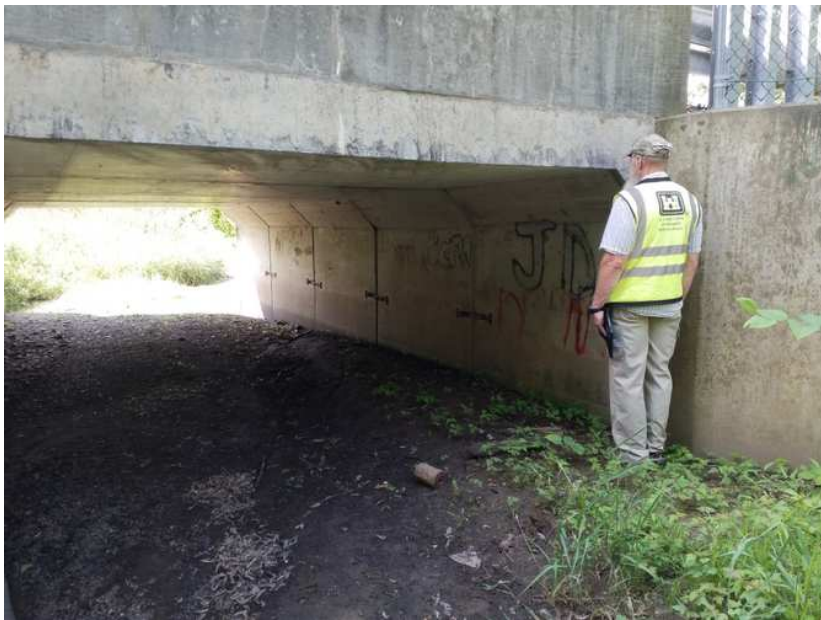
Culvert is highly impacted by sediment. Estimate 25% blocked. Sponsor should clean out.
(M)

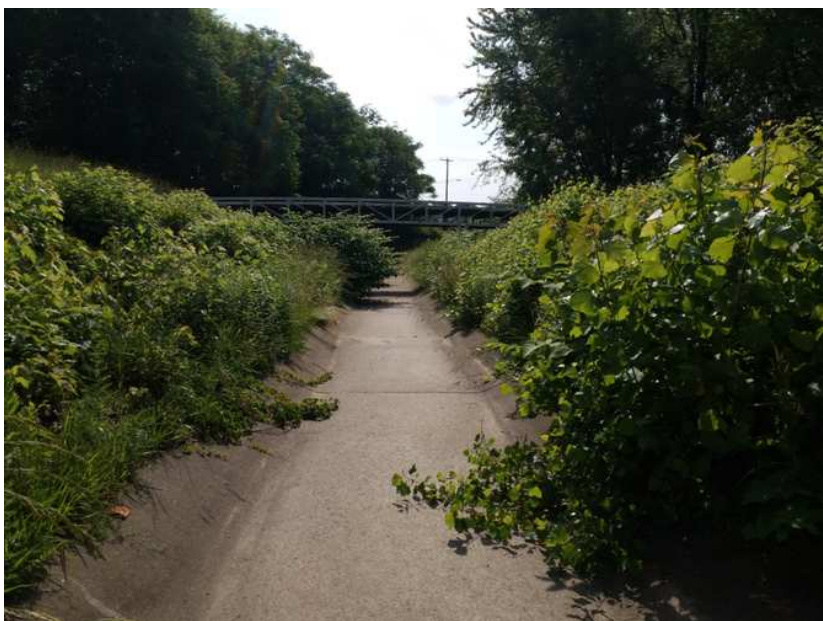
Inspect ID: 2024-0018

Typical conditions. Knottweed growing on both banks (M)

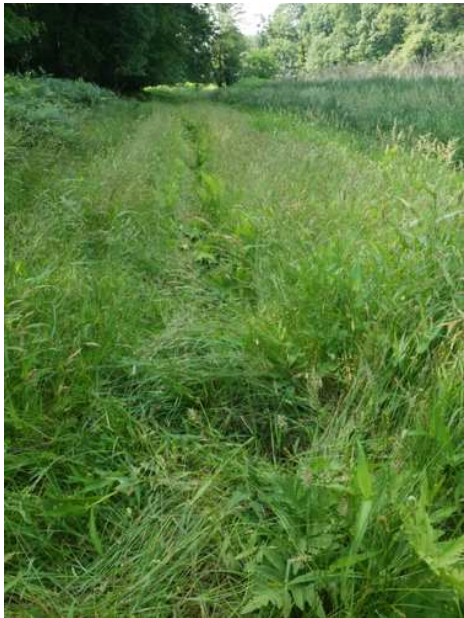
Inspect ID: 2024-0026
Rated Item: 3. Encroachments
Lat/Long: 41.33008/-75.82362
Caption:
Groundhog holes along channel (M)

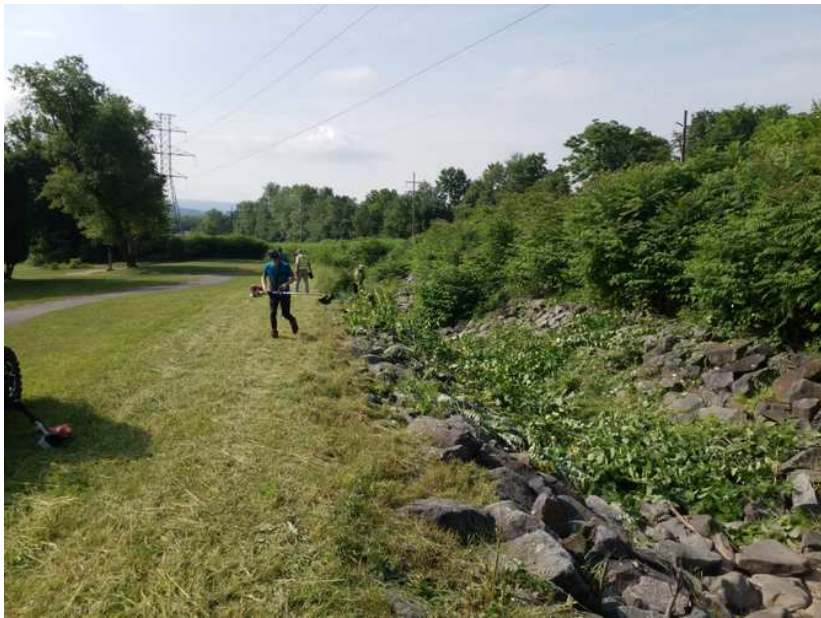
Inspect ID: 2024-0011

Typical conditions of rip rap, some knottweed starting to grow and should be removed (A)

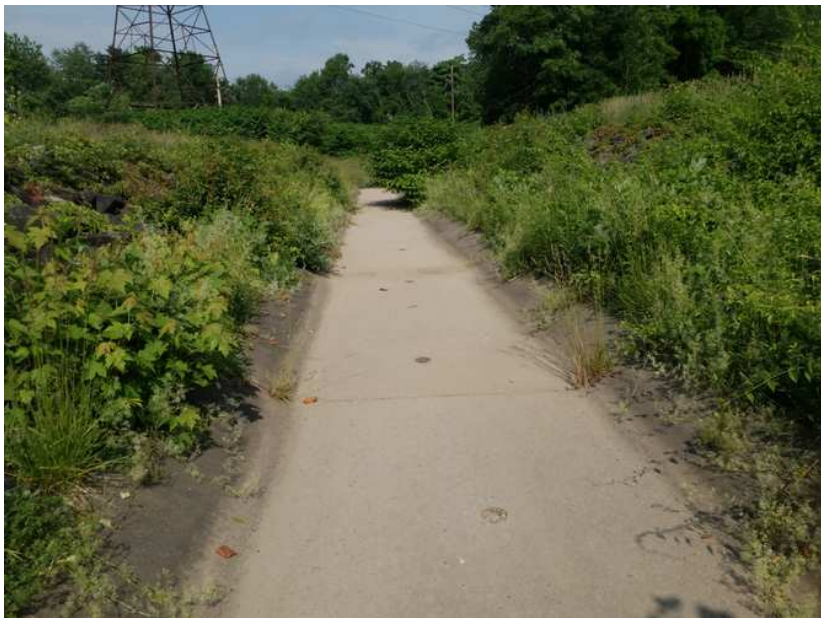
Inspect ID: 2024-0011

Typical conditions of rip rap, Knottweed taking over, should be removed (M)

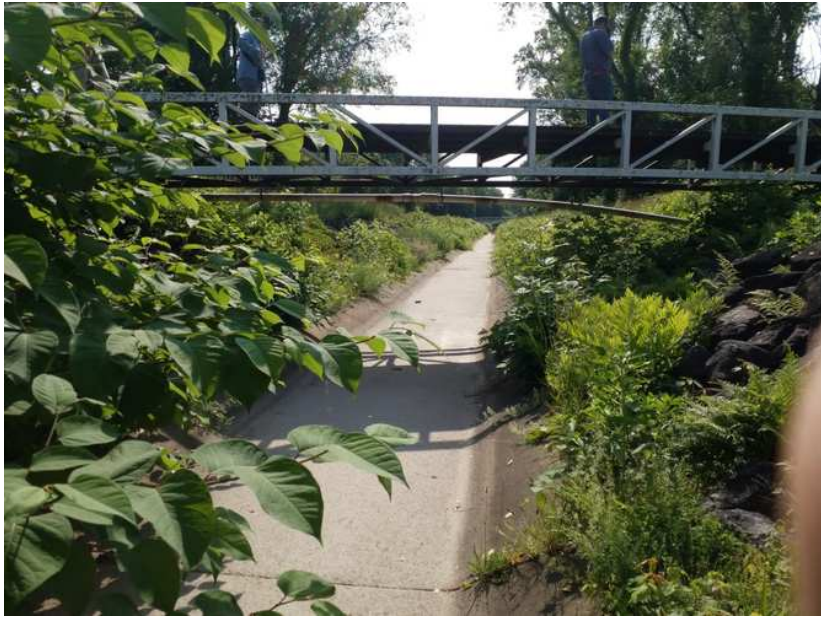
Inspect ID: 2024-0016

Typical conditions of rip rap, Knottweed taking over, should be removed (M)

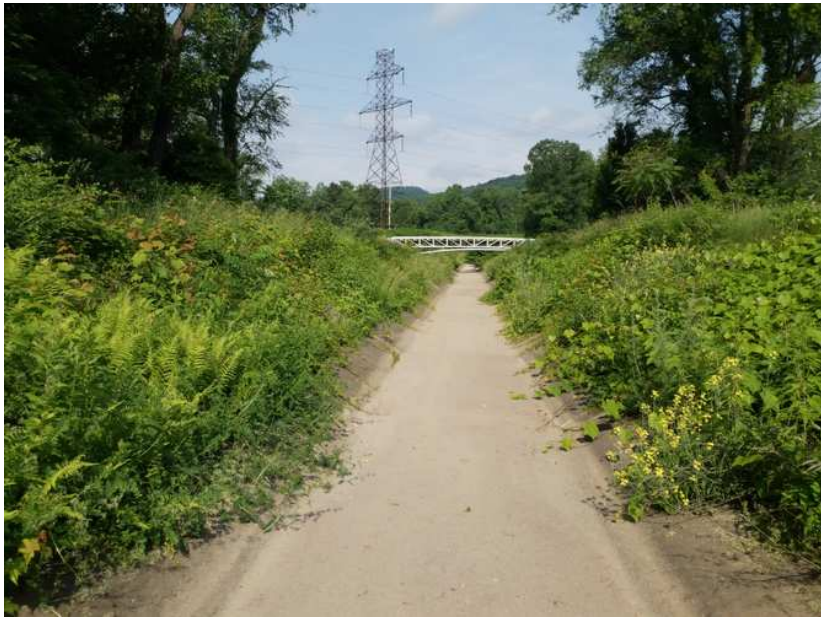
Inspect ID: 2024-0016

Typical conditions of rip rap, Knottweed taking over, should be removed (M)

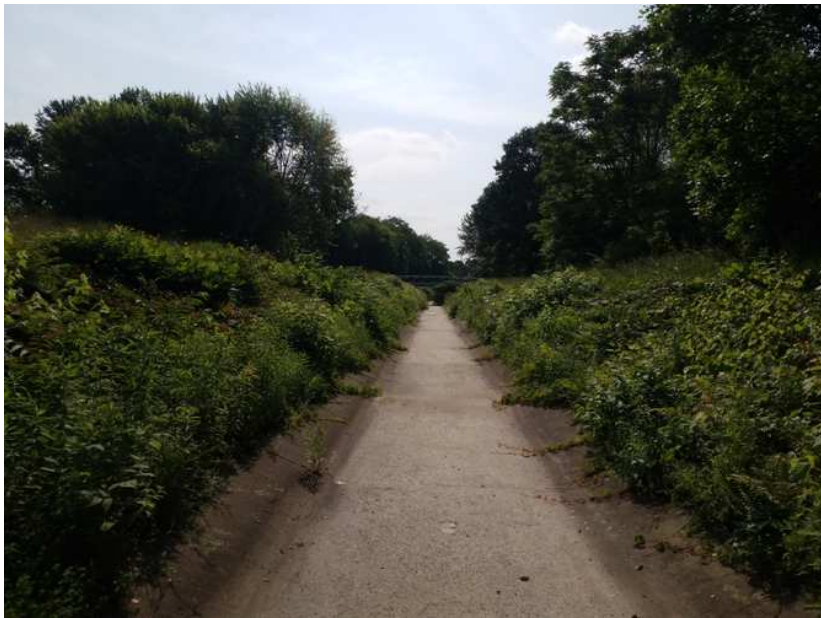
Inspect ID: 2024-0017

Typical conditions of rip rap, Knottweed taking over, should be removed (M)

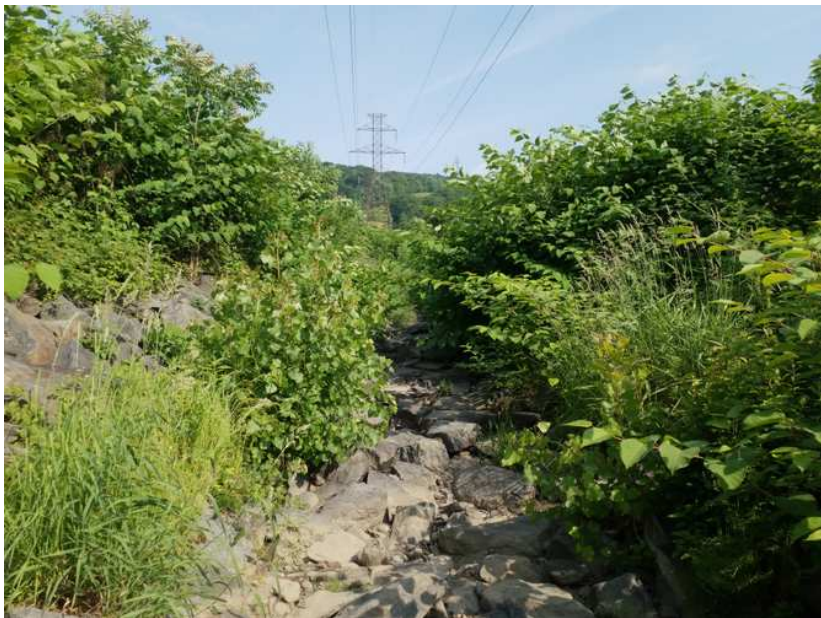
Inspect ID: 2024-0017

Typical conditions of rip rap, Knotweed taking over, should be removed (M)

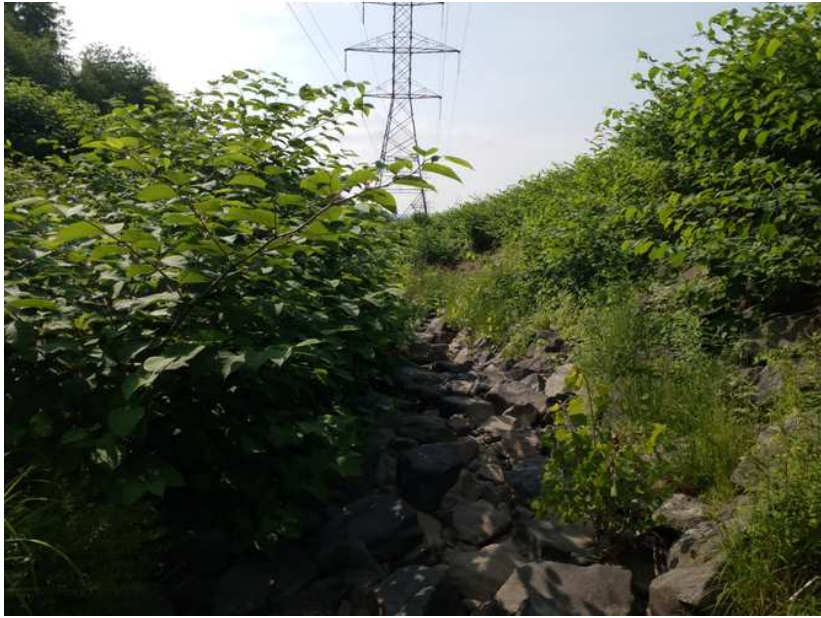
Inspect ID: 2024-0013

Typical conditions of rip rap, Knotweed taking over, should be removed (M)

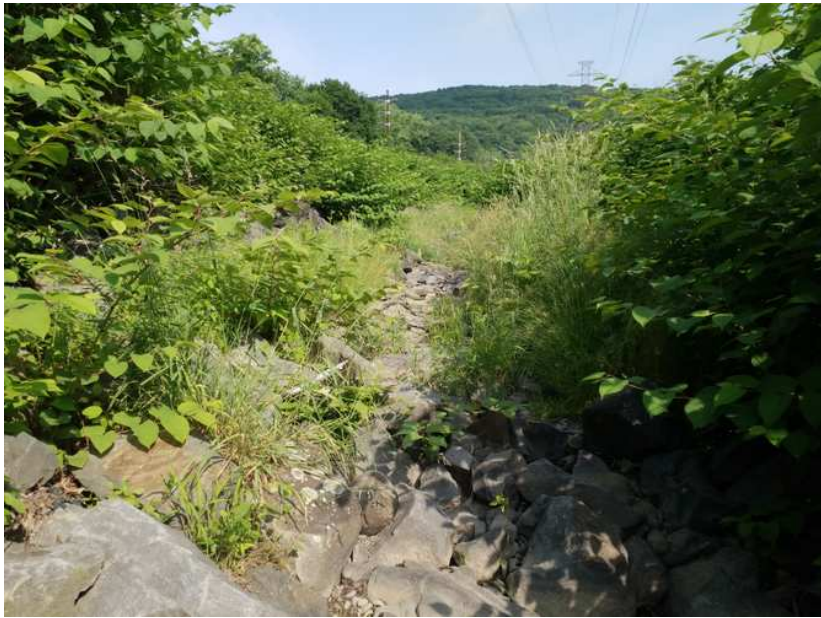
Inspect ID: 2024-0013

Typical conditions of rip rap, Knottweed taking over, should be removed (M)

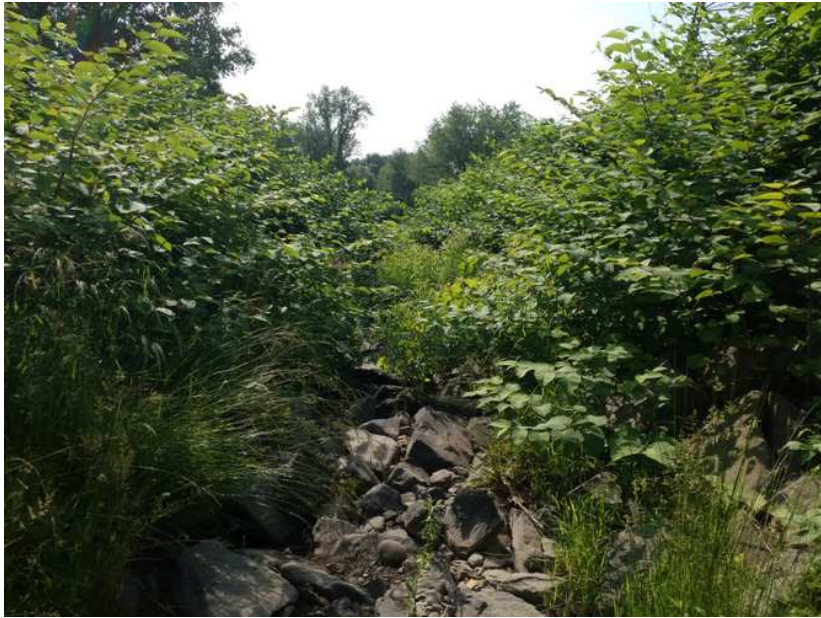
Inspect ID: 2024-0014

Typical conditions of rip rap, Knottweed taking over, should be removed (M)

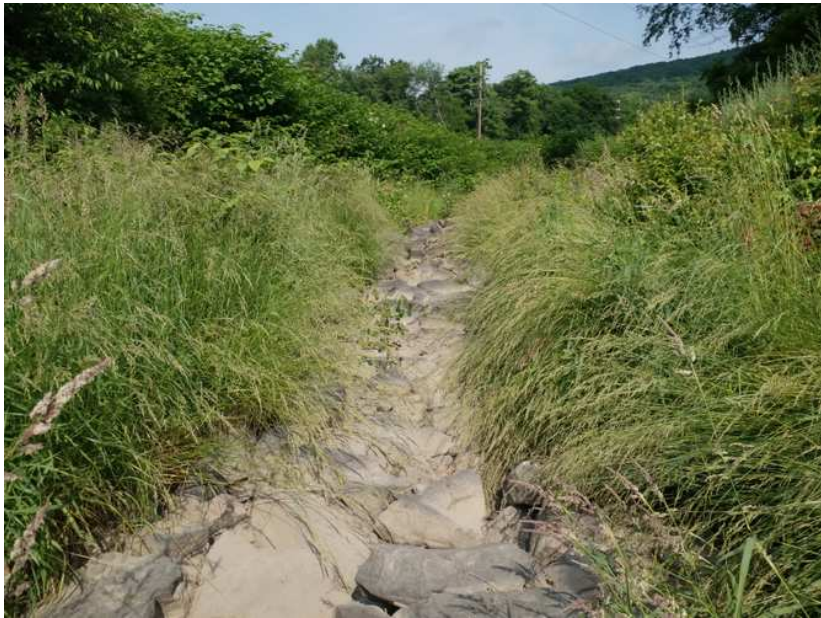
Inspect ID: 2024-0014

Typical conditions of rip rap, Knottweed taking over, should be removed (M)

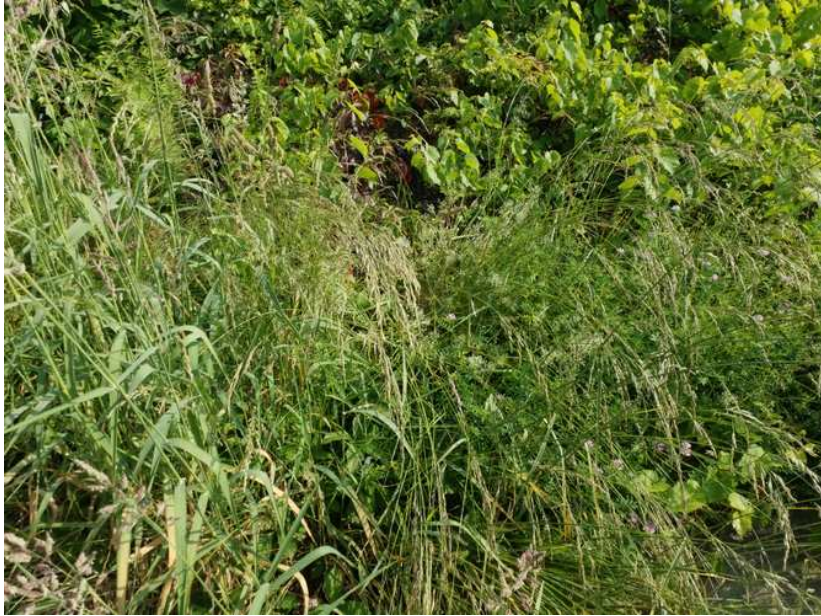
Inspect ID: 2024-0015

Typical conditions. At transition from rip rap to concrete. Note. Groundhog on right bank about 3 feet from channel bottom (M)

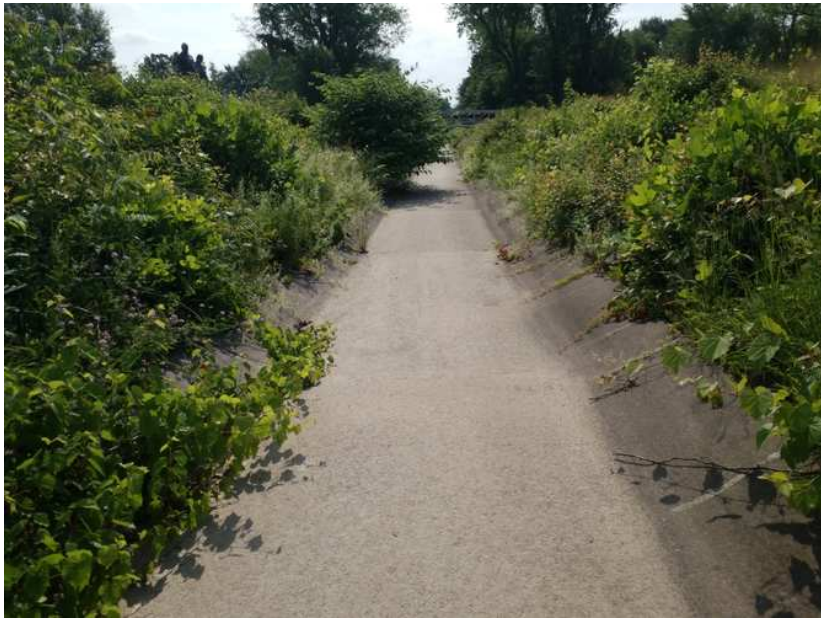
Inspect ID: 2024-0015

Typical conditions. At transition from rip rap to concrete. Note. Groundhog on right bank about 3 feet from channel bottom (M)

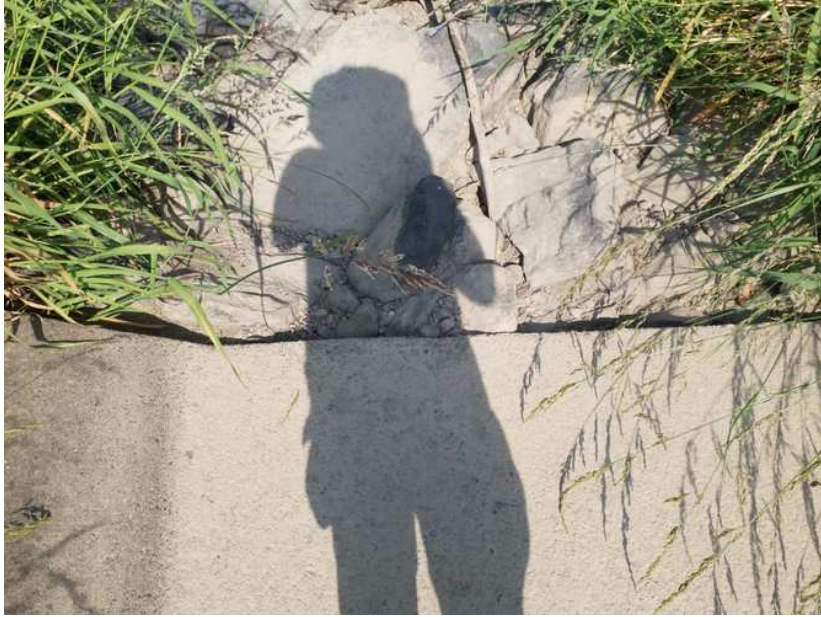
Inspect ID: 2024-0015

Typical conditions. At transition from rip rap to concrete. Note. Groundhog on right bank about 3 feet from channel bottom

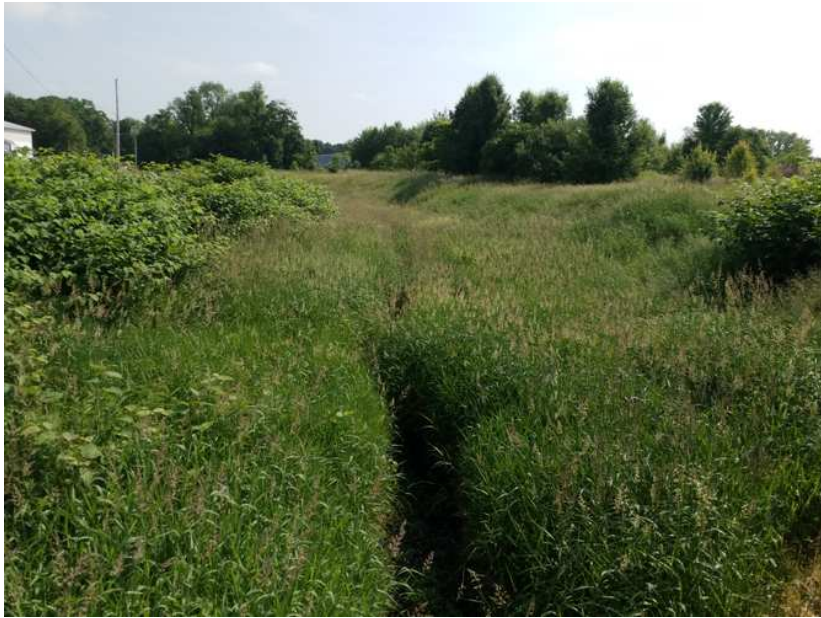
Inspect ID: 2024-0022

Typical conditions, knottweed on both banks (M)

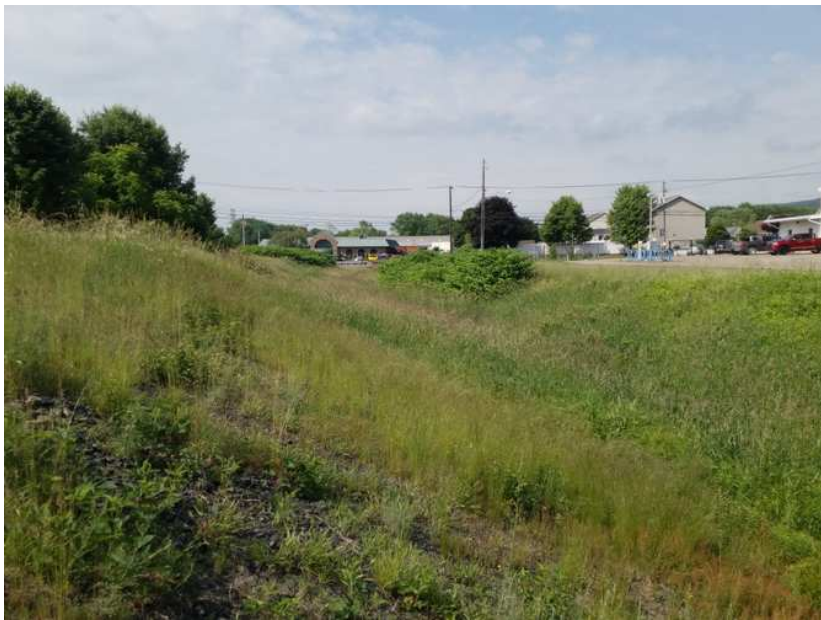
Inspect ID: 2024-0022

Typical conditions, knottweed on both banks (M)

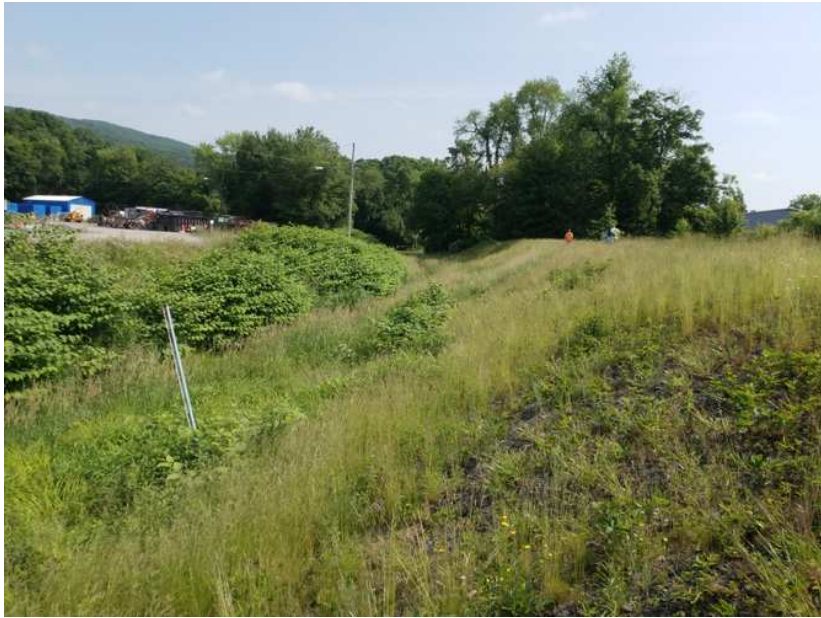
Inspect ID: 2024-0023

Typical conditions. Unlined Channel, knottweed on both banks (M)

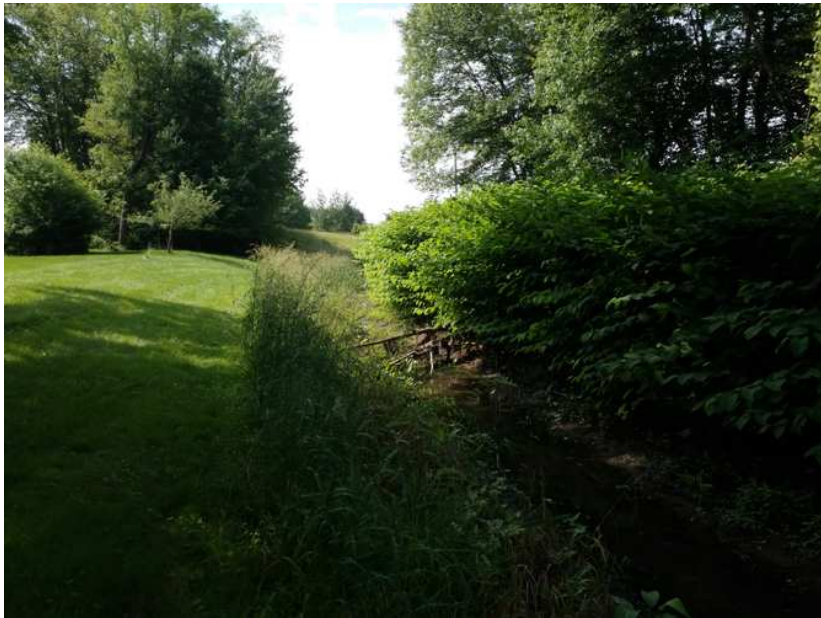
Inspect ID: 2024-0023

Typical conditions. Unlined Channel, knottweed on both banks (M)

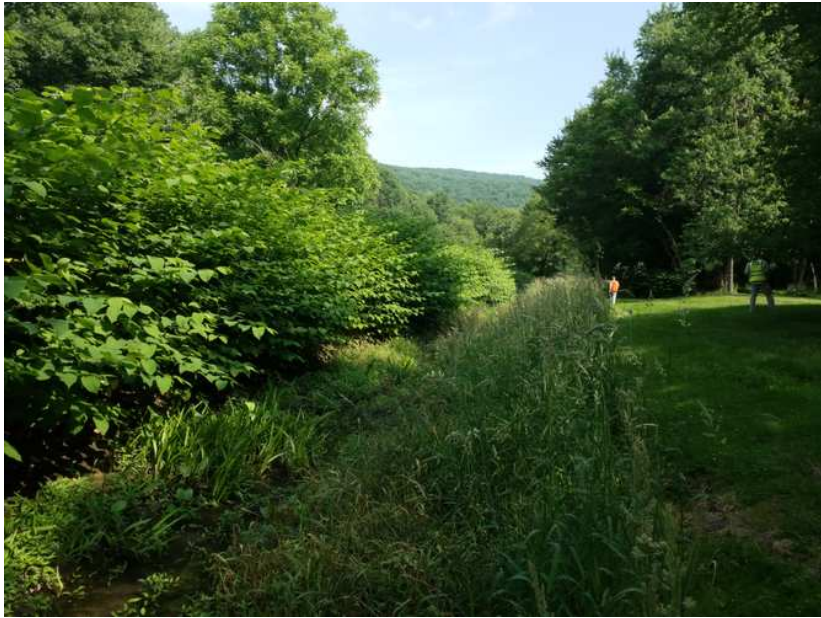
Inspect ID: 2024-0024

Typical conditions. Natural conditions channel bottom, knottweed on both banks (M)

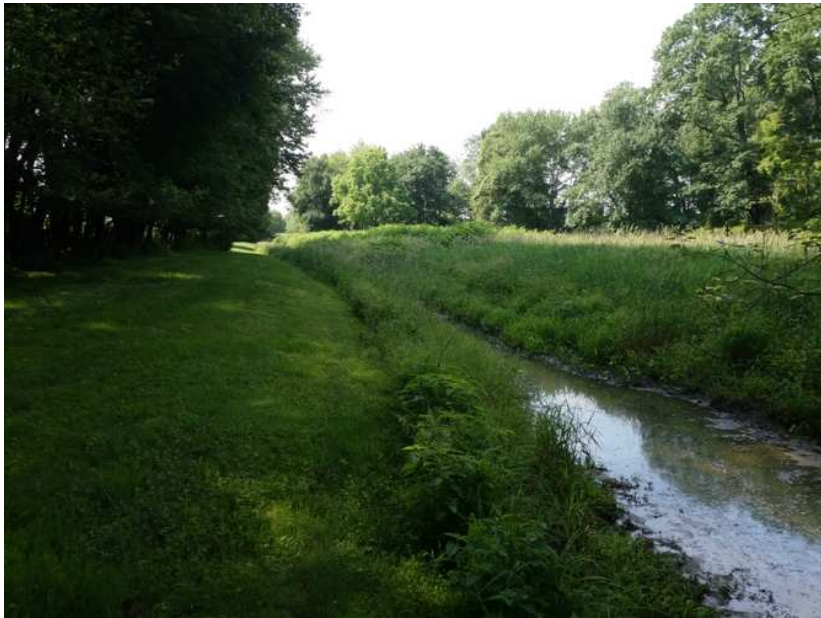
Inspect ID: 2024-0024

Typical conditions. Natural conditions channel bottom, knottweed on both banks (M)

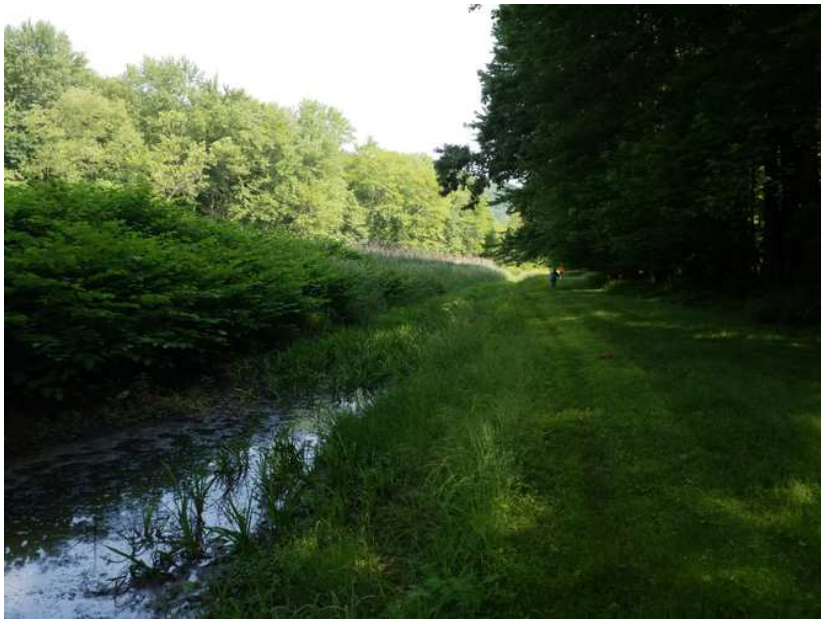
Inspect ID: 2024-0025

Typical conditions of natural channel, Knottweed on right bank (M)

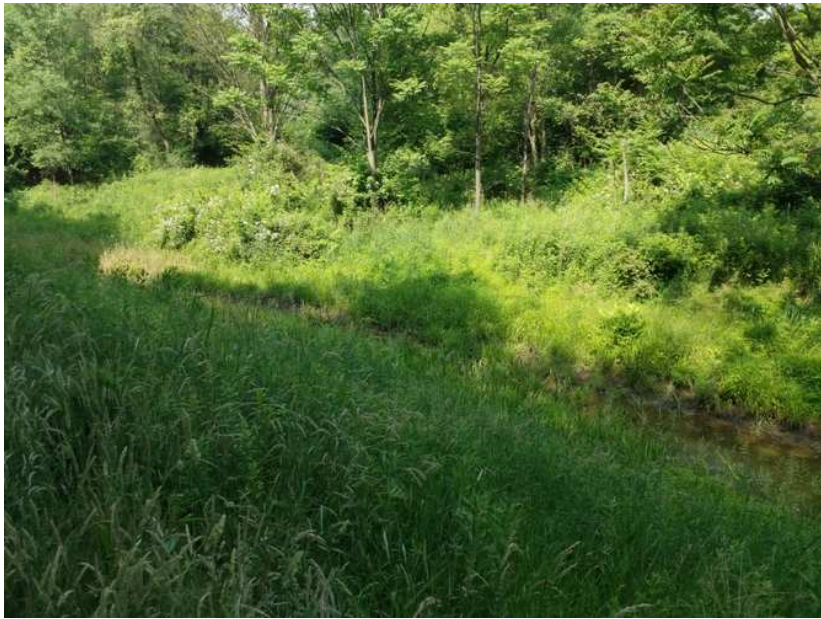
Inspect ID: 2024-0025

Typical conditions of natural channel. Knottweed on right bank (M)

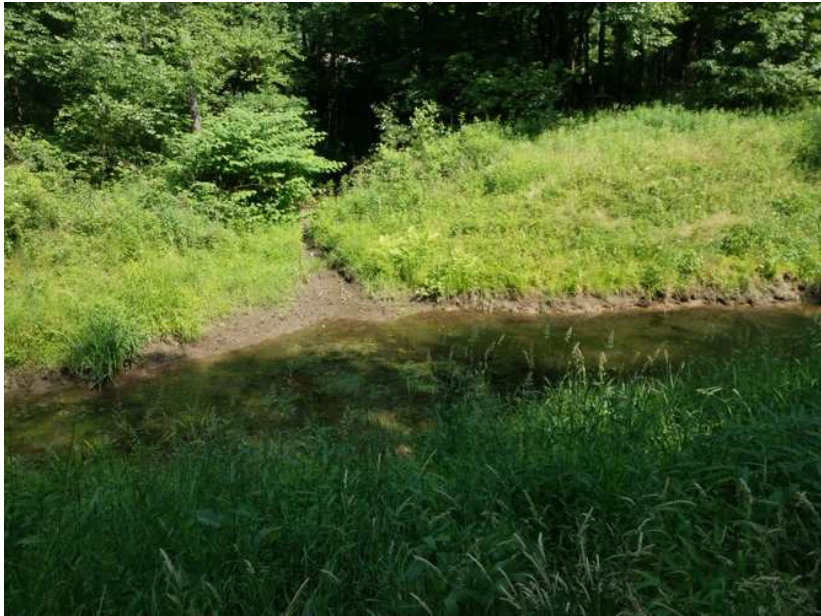
Inspect ID: 2024-0027

Typical conditions at confluence of tributary, knottweed on both banks (M)

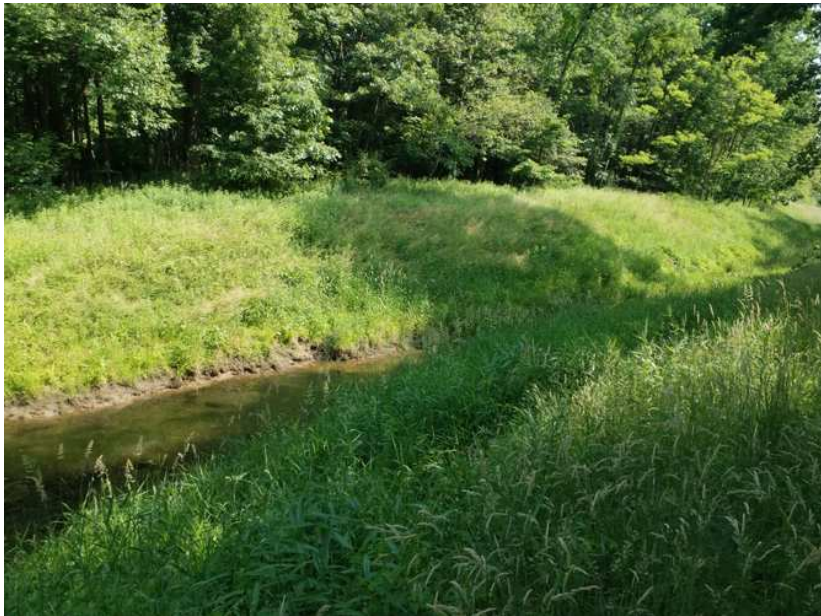
Inspect ID: 2024-0027

Typical conditions. at confluence of tributary, note knotweed (M)

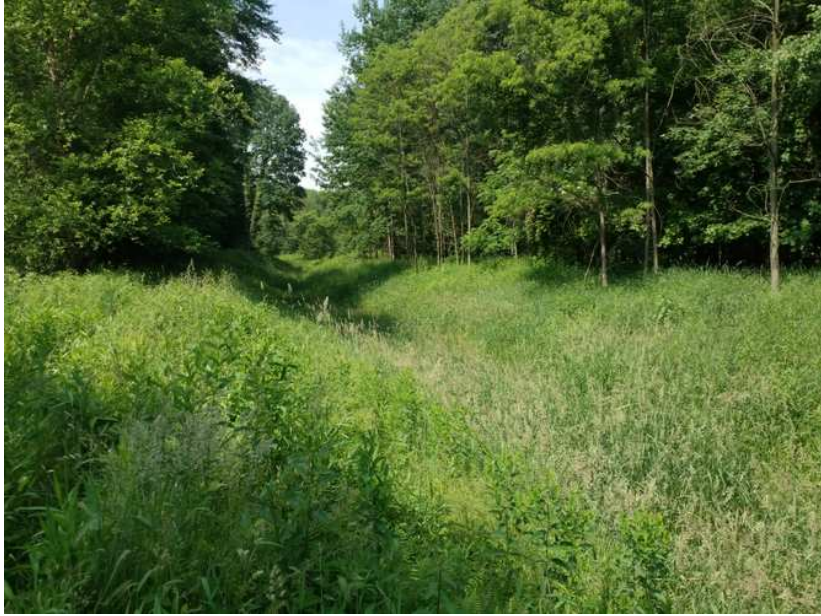
Inspect ID: 2024-0027

Typical conditions. at confluence of tributary, note knotweed (M)

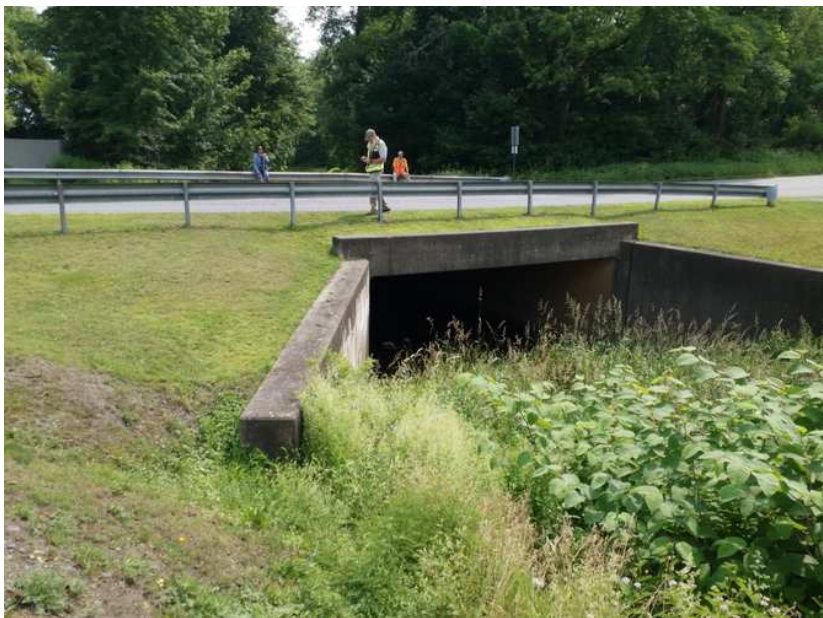
Inspect ID: 2024-0029

Typical conditions of natural channel. Note Knotweed (M)

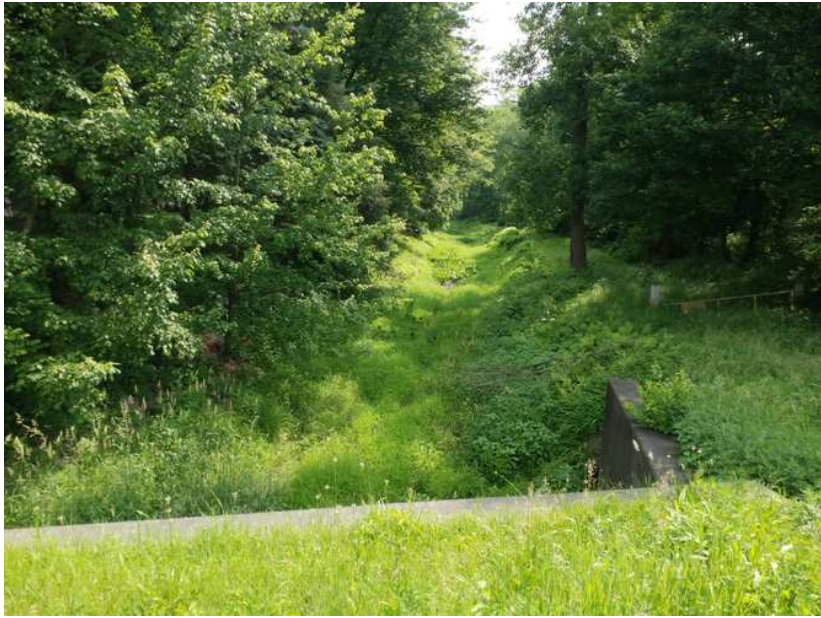
Inspect ID: 2024-0029

Typical conditions of natural channel. Note Knotweed (M)

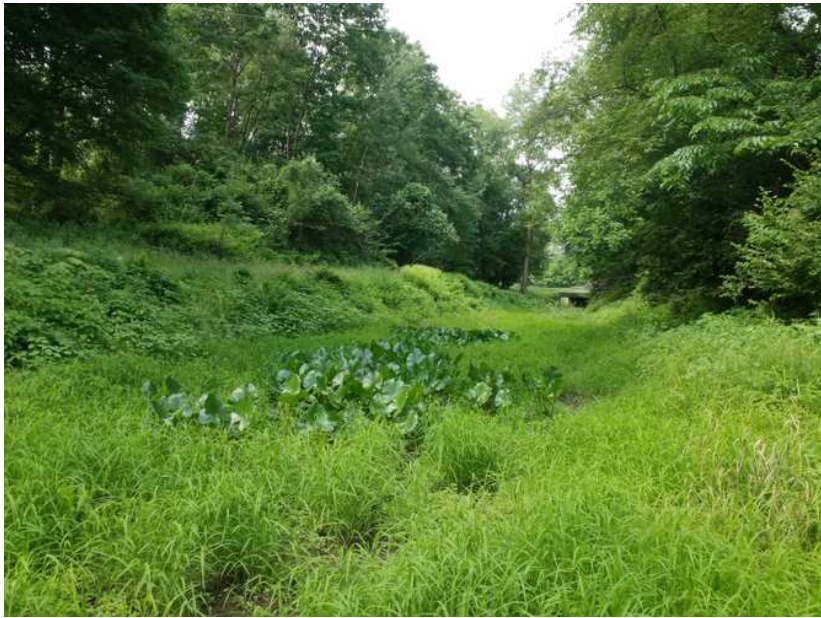
Inspect ID: 2024-0029

Typical conditions of natural channel. Note Knottweed (M)

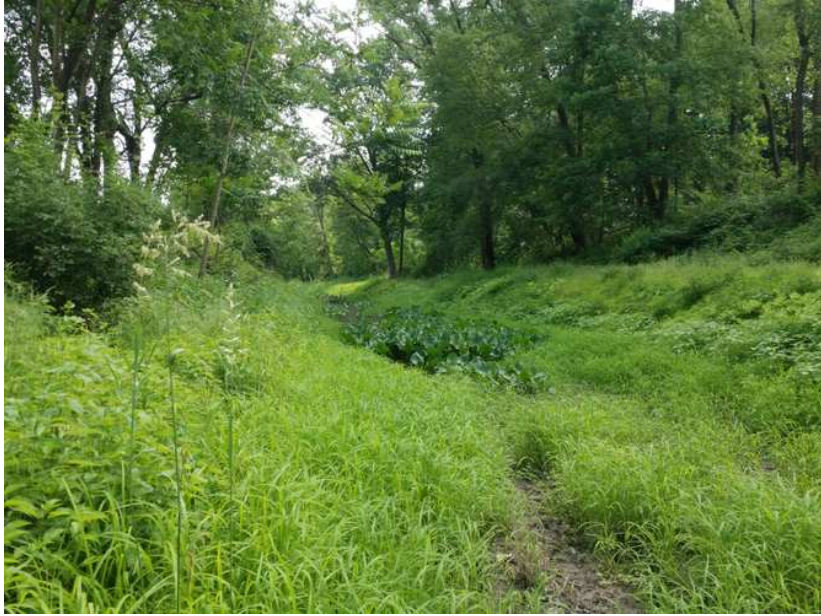
Inspect ID: 2024-0031

Typical conditions of natural channel. Note Knottweed (M)

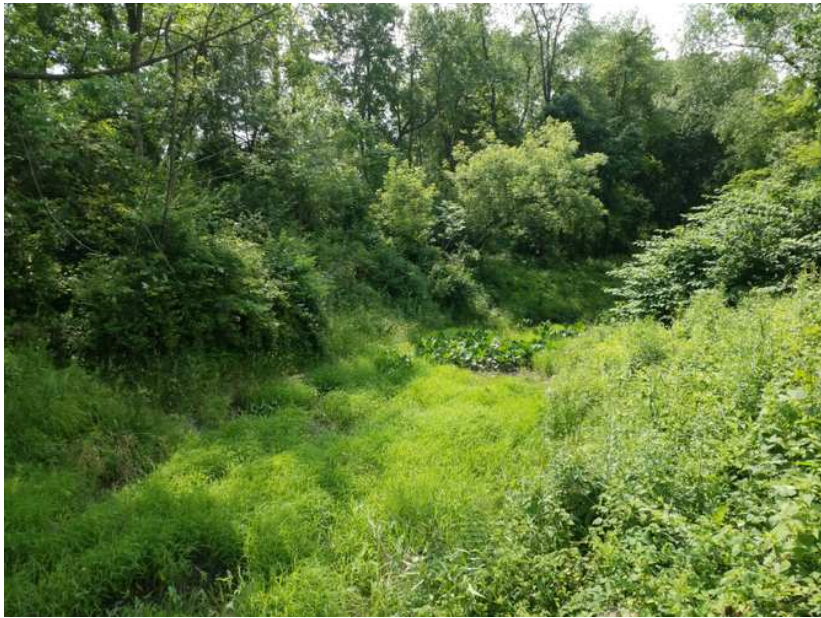
Inspect ID: 2024-0031

Typical conditions of natural channel. Note Knottweed (M)
