Exeter Flood Risk Management Project

Levee Inspection Report

Name of System: Exeter - Hicks Creek

Inspection Report Prepared by: Daniel Risley, USACE Baltimore Date(s) of Inspection: 06/05/2024 - 06/05/2024

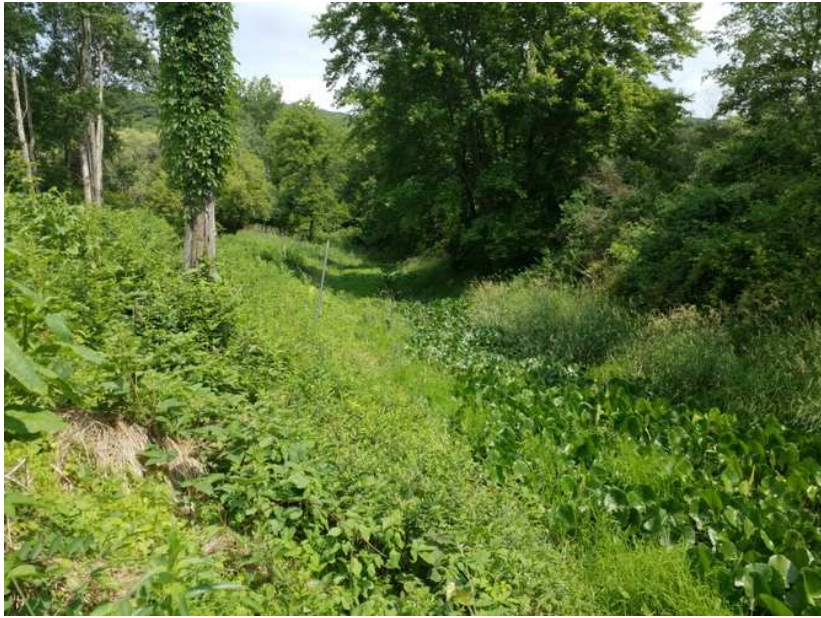
Inspect ID: 2024-0033

Typical conditions of natural channel. Note Knottweed (M)

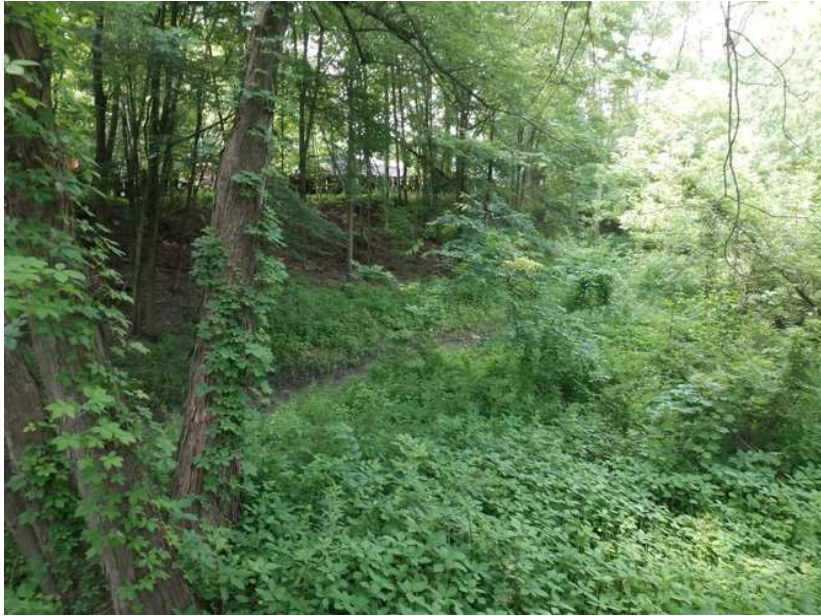
Inspect ID: 2024-0033

Typical conditions of natural channel. Note Knottweed (M)

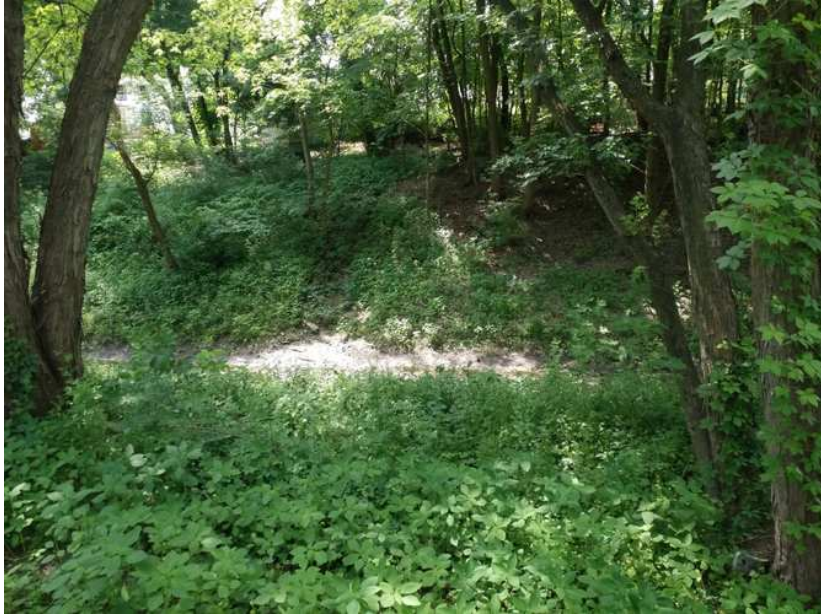
Inspect ID: 2024-0034

Typical conditions of natural channel. Note Knottweed (M)

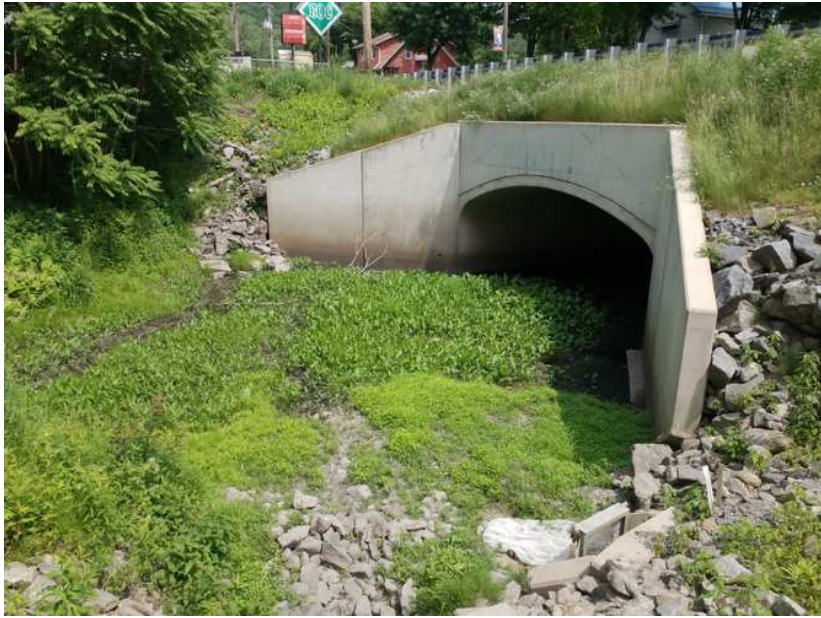
Inspect ID: 2024-0034

Typical conditions of natural channel. Note Knottweed (M)
