Exeter Flood Risk Management Project

Levee Inspection Report

Name of System: Exeter - Hicks Creek

Inspection Report Prepared by: Daniel Risley, USACE Baltimore Date(s) of Inspection: 06/05/2024 - 06/05/2024

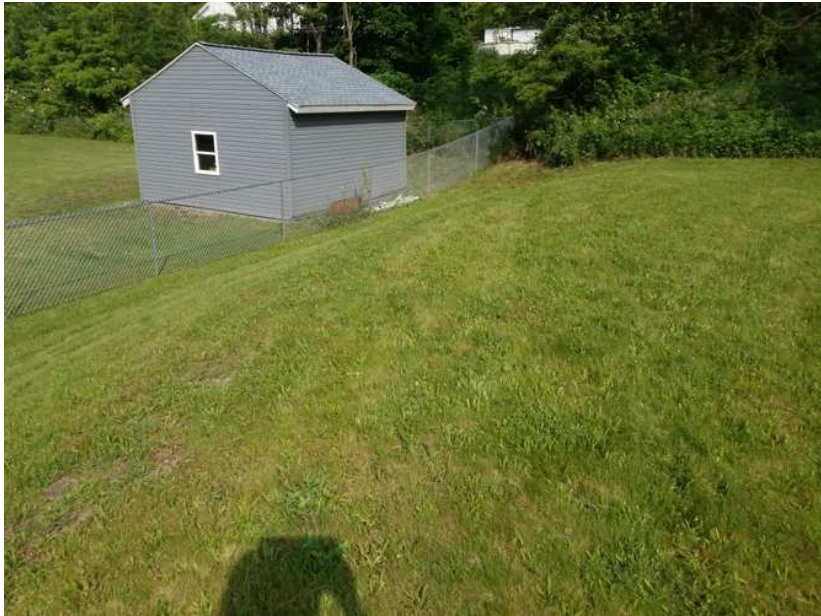
Typical conditions: Debris Basin Embankment, note vegetation at toe on wet side (M)

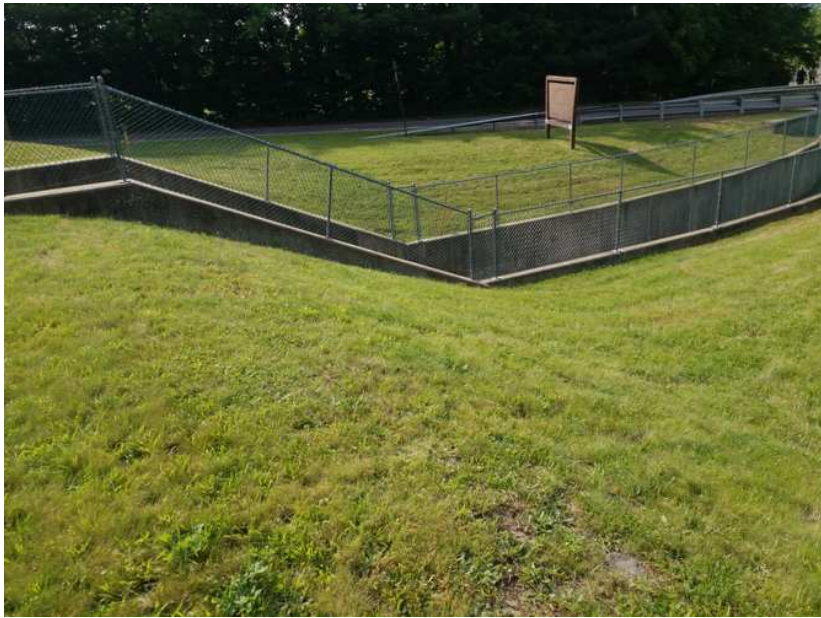
Typical conditions: Debris Basin Embankment, (A)

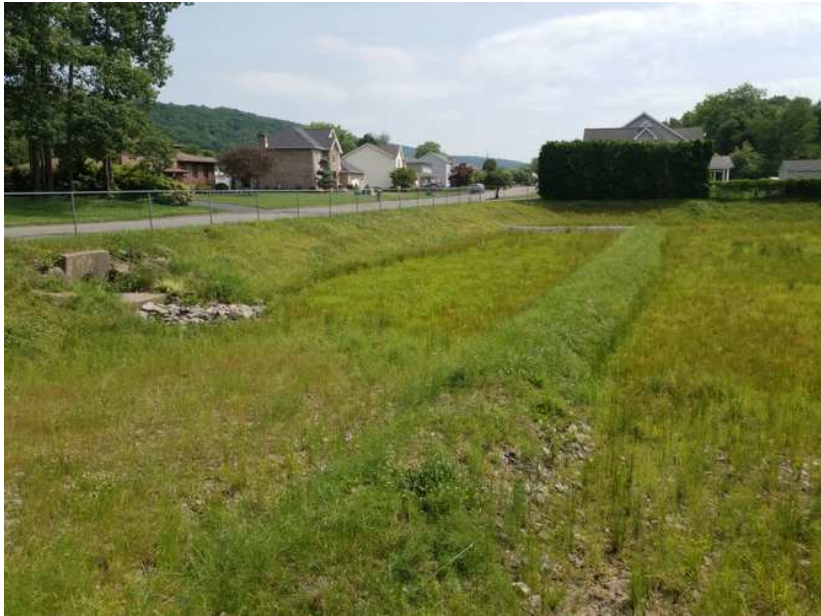
Typical conditions. A few feet of sediment is in the Strumer Street basin. Sediment should be removed (M)

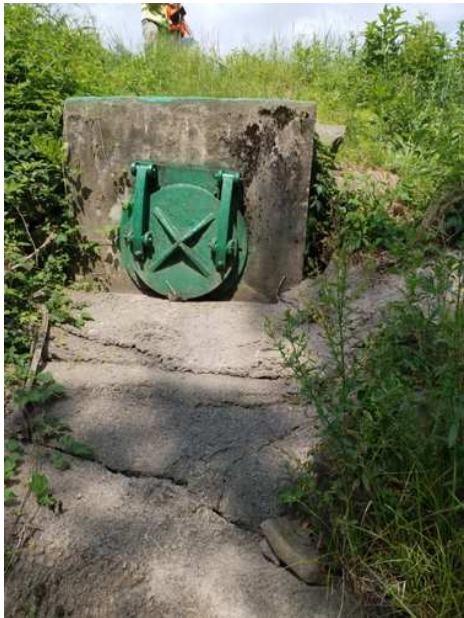
Typical conditions of SWM facility at low flow outfall. Vegetation needs to be cleared out, Donna's Way facility (M)

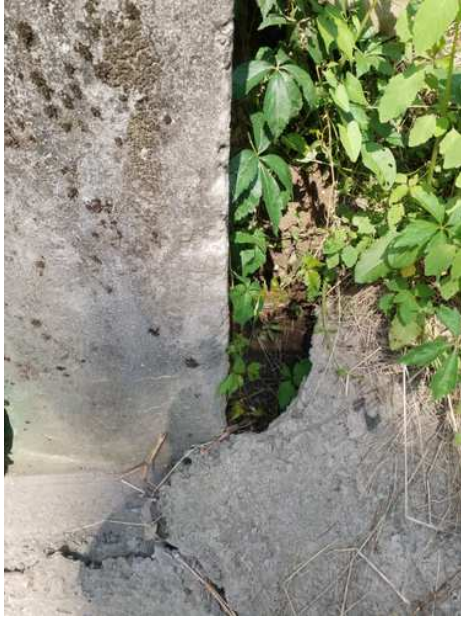
SD discharge. Headwall tilting and erosion adjacent to structure, Donna's Way facility (M)

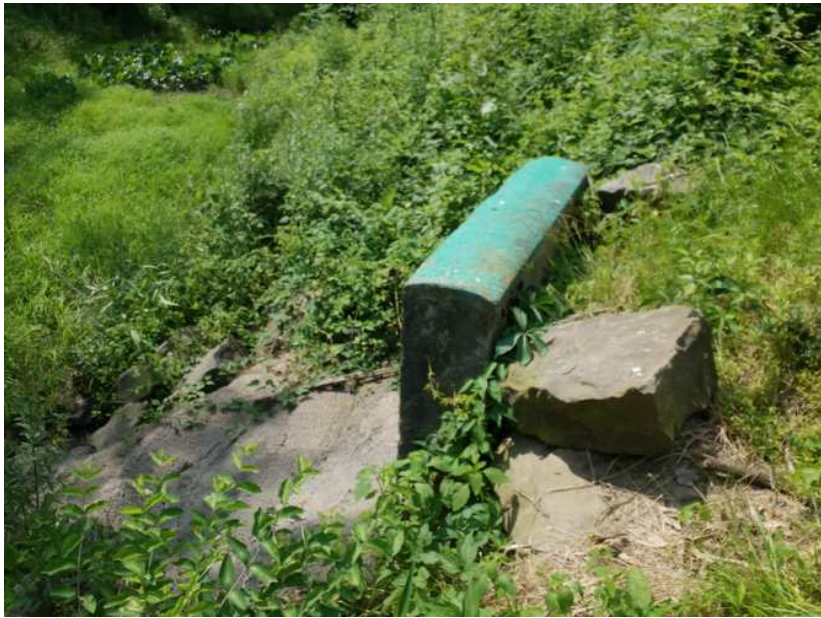
SD discharge. Headwall tilting and erosion adjacent to structure, Donna's Way facility (M)

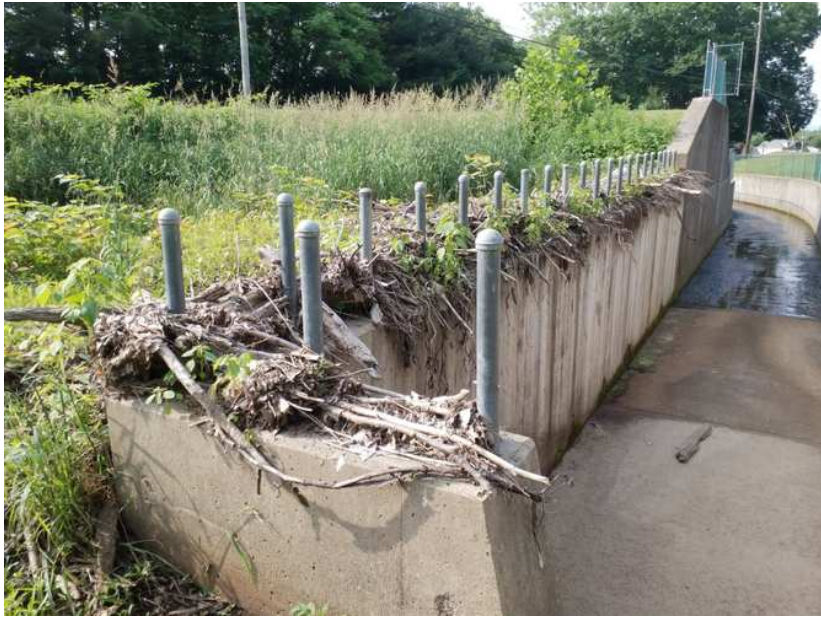
SD discharge. Headwall tilting and erosion adjacent to structure, Donna's Way facility (M)

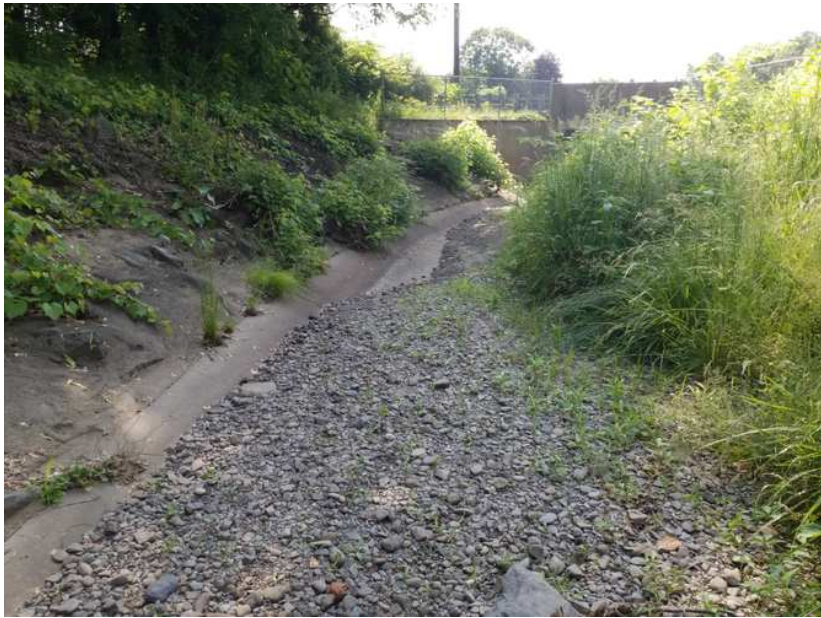
Concrete channel is 90% full of sediment. Concrete portion is 18 inch high. Sponsor needs to clean out. (M)

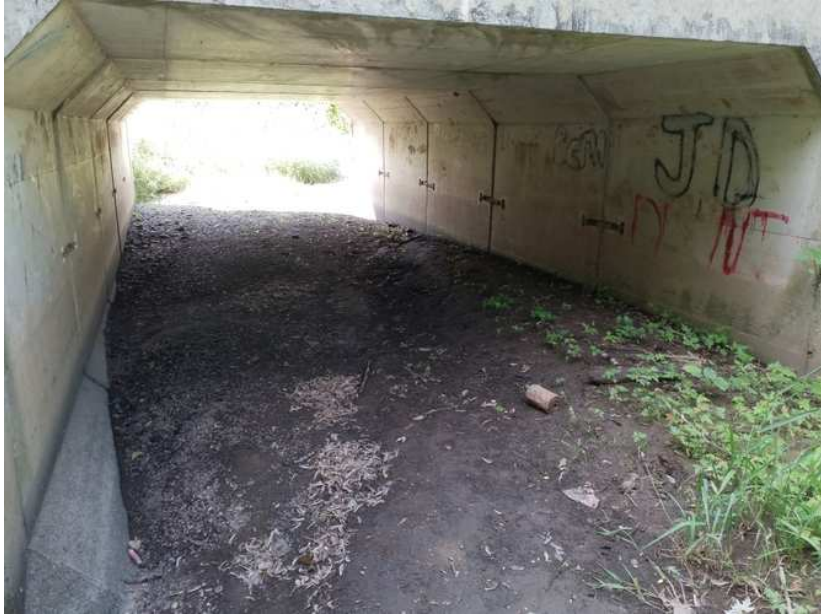
Concrete channel is 90% full of sediment. Concrete portion is 18 inch high. Sponsor needs to clean out (M)

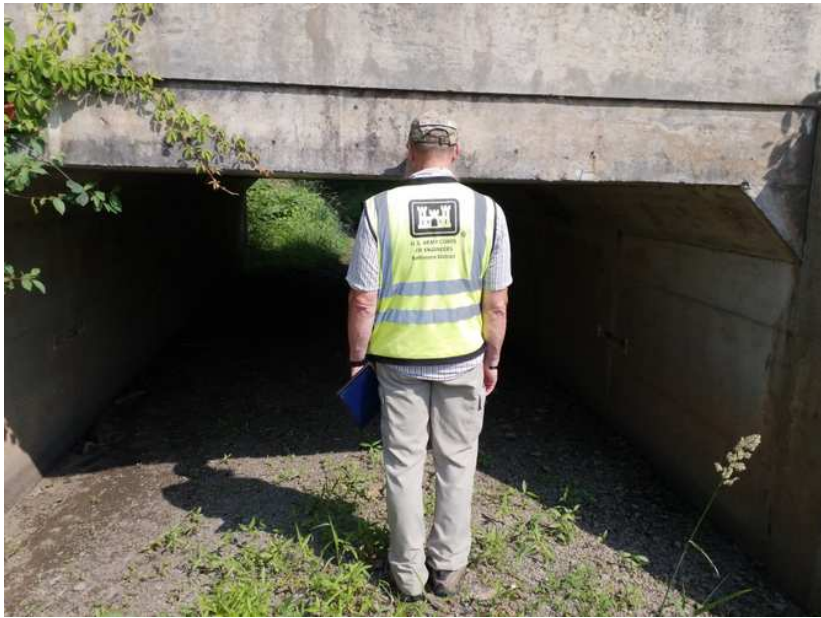
Culvert is highly impacted by sediment. Estimate 25% blocked. Sponsor should clean out.
(M)

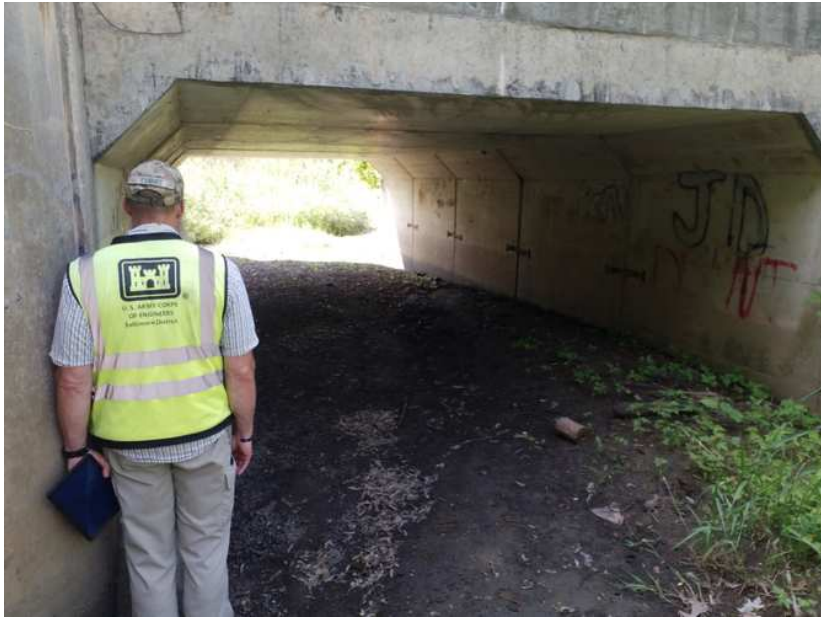
Culvert is highly impacted by sediment. Estimate 25% blocked. Sponsor should clean out.
(M)

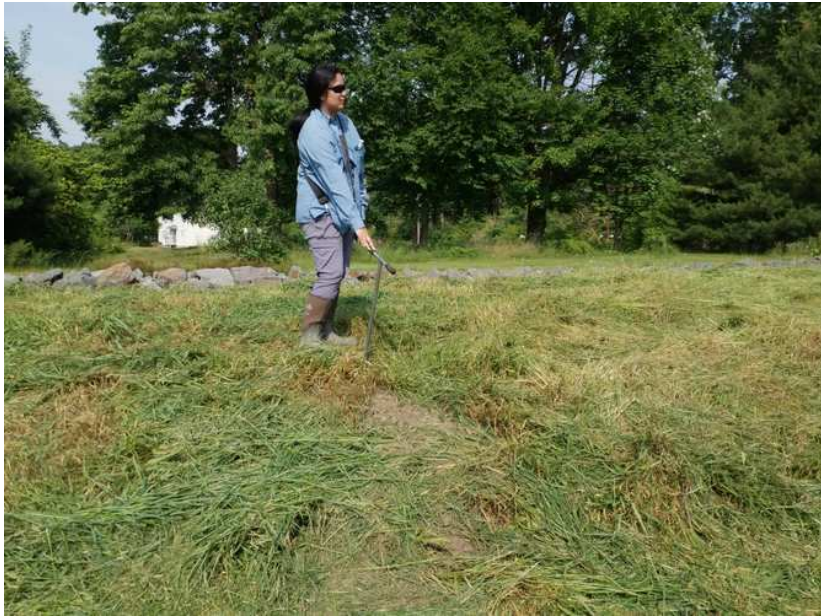
Inspect ID: 2024-0026
Rated Item: 3. Encroachments
Lat/Long: 41.33008/-75.82362
Caption:
Groundhog holes along channel (M)
